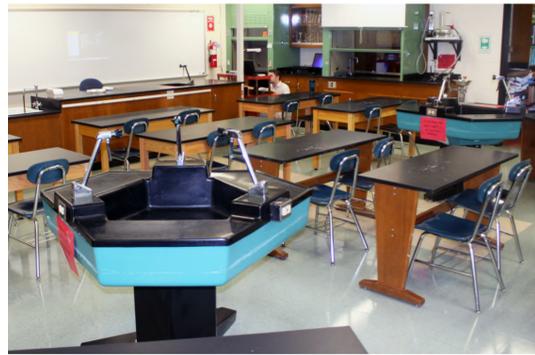
High School Science Lab

Existing science rooms do not allow all students to receive lab & lecture within the same room, from the same instructor. Additionally, the rooms are outdated and do not support 21st Century Technology.

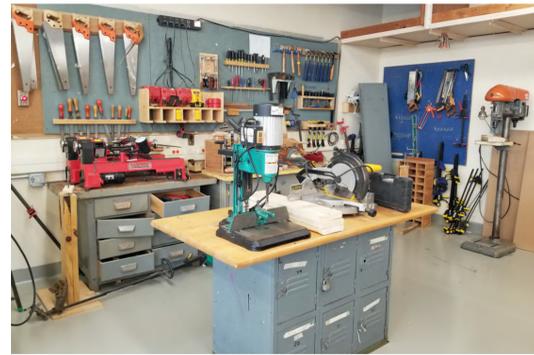
High School Technology/Wood Shop

The existing wood shop is not adequate in size or amenities to support the program's goals. A building addition and reconfiguration of existing building space would allow for expansion of program offerings.

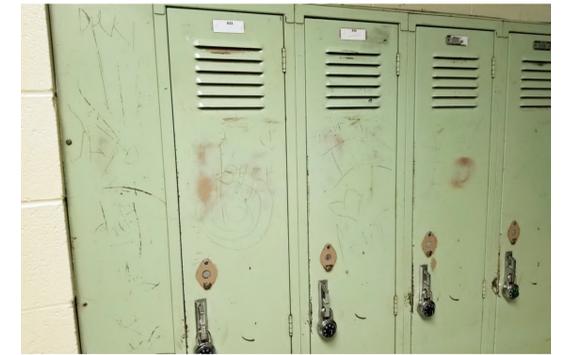
High School Corridor Lockers

Existing corridor lockers in the 300-wing are in poor condition and need replacement.

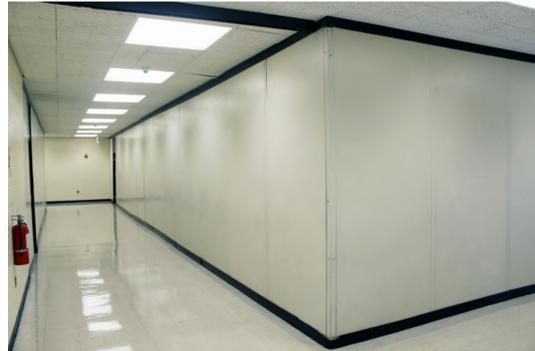
Middle School Classroom Partitions

Existing classroom walls are temporary "demountable partitions" which lack adequate sound separation and limit storage and electrical capacity. Safe & secure door operation within these walls is problematic.

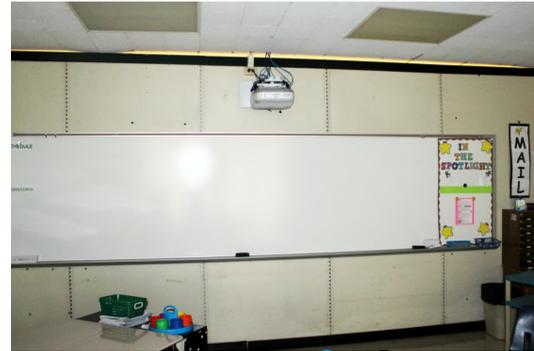
Middle School Classroom Partitions

Existing walls run below ceilings, allowing for sound transmission between classrooms & corridor. New walls that extend to the underside of the roof would provide proper sound isolation between classrooms.

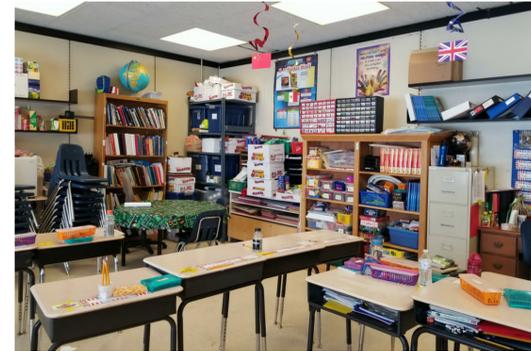
Middle School Classroom

Existing storage capabilities are limited due to the wall construction and lack of built-in storage solutions. As a result, classrooms feel cluttered and distract from focused learning.

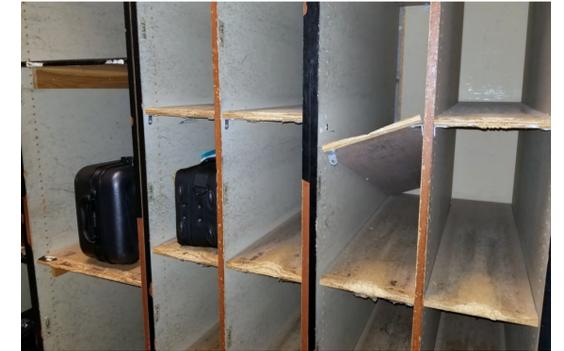
Middle School Music Instrument Storage

Existing music instrument storage has exceeded its useful life and is in poor condition, requiring replacement.

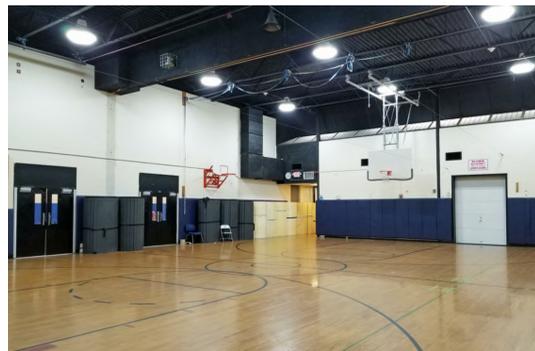
Middle School Gymnasium

The existing gymnasiums are not sufficient to support the physical education of all grade levels currently housed at this building. Roof height does not meet requirements for basketball and volleyball competition.

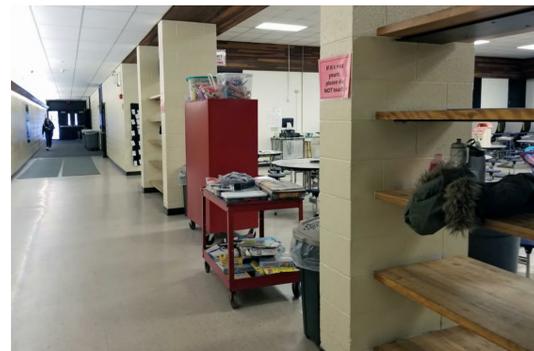
Middle School Cafeteria/Corridor

The cafeteria is open to the corridor without the ability to shelter students in-place in the event of a lockdown. New walls and doors would be provided to properly enclose and secure the room.

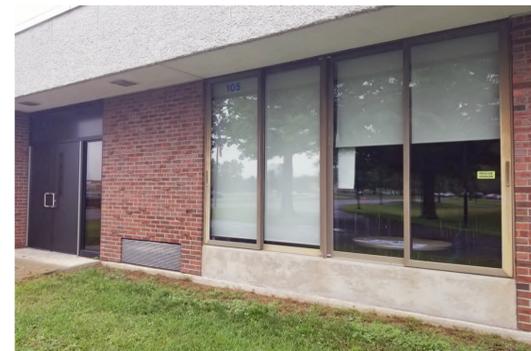
Middle School Classroom & Office Windows

Existing windows are not energy efficient. Additionally, these windows are low to the ground and pose a security concern.

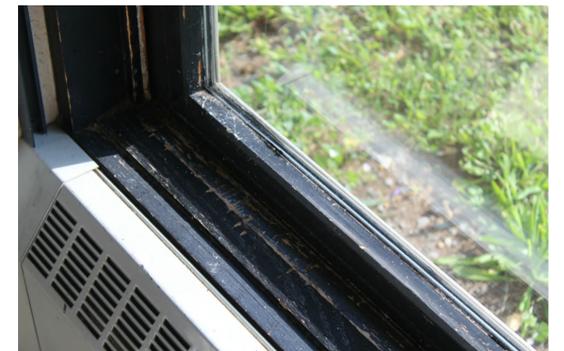
Middle School Classroom & Office Windows

Existing windows are single-pane glass which offer no thermal protection. They have also begun to fail and allow water penetration.

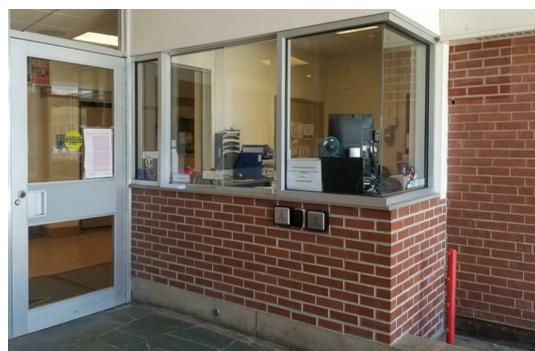
High School Vestibule

Existing windows are open to intruders and easily compromised. Sliding windows would be replaced with fixed, bullet-resistant windows and surrounding doors/windows would receive impact-resistant film.

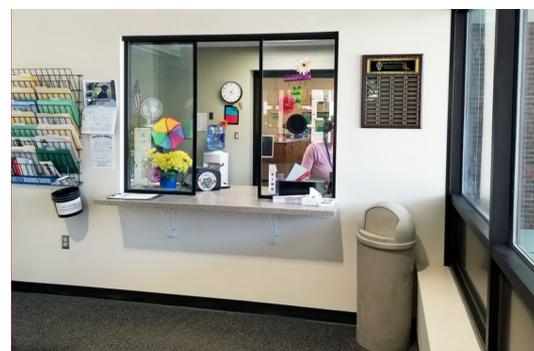
Middle School Vestibule

Existing windows are open to intruders and easily compromised. Sliding windows would be replaced with fixed, bullet-resistant windows and surrounding doors/windows would receive impact-resistant film.

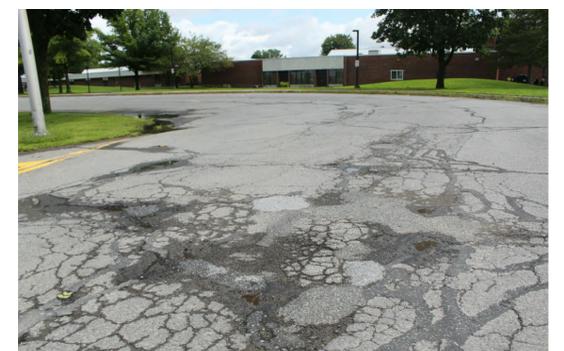
Middle School Entry Drive/Parking Lot

Existing asphalt pavement is failing and in need of replacement. Pavement around the Middle School would be reconfigured to improve traffic flow and safety.
